Newton Corner

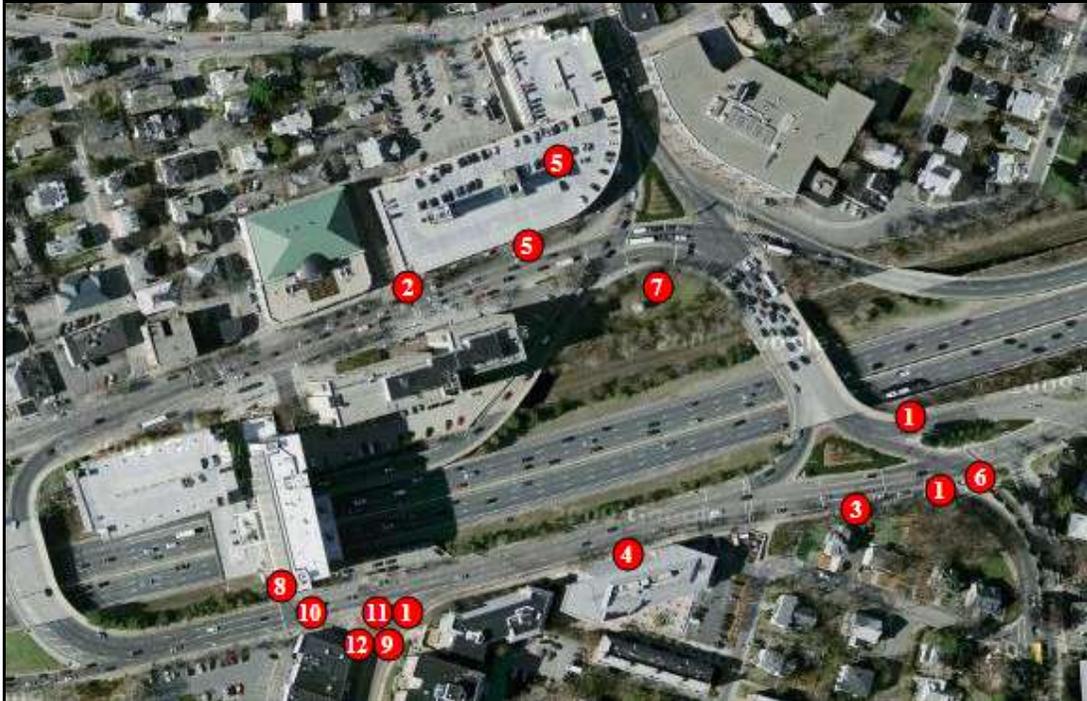
Figure 1: Newton Corner Problems and Opportunities Map

In this study area, we noticed many problematic patterns that involved inaccessibility and unsafe facilities. This included poor surface conditions, and an inaccessible path through the Crowne Plaza Hotel. Also, curb cuts and signals were not always designed to the accessibility standards provided by the ADA. In this section, we discuss the areas for improvement found in Newton Corner as well as potential solutions for these problems, as shown in Figure 15.

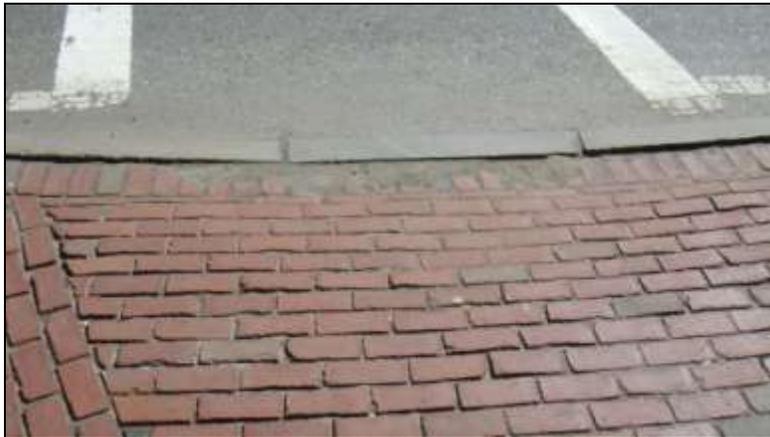
Figure 2: Brick Surface along Washington Street

- 2. Hazardous Brick Surfaces:** Washington Street, for example, has a partial brick surface, as shown in Figure 16. Brick surfaces are extremely difficult to maintain and can be hazardous. The ADA suggests uneven surfaces such as bricks should be avoided.

Recommendation: Replace with pressed concrete. We recommend replacing the brick surfaces with pressed concrete. Pressed concrete maintains some of the aesthetic appeal of brick while providing a safer traveling surface. This can be implemented systematically over time. As the brick degrades, pressed concrete could be used as a replacement. An example of pressed concrete is shown below in Figure 17.

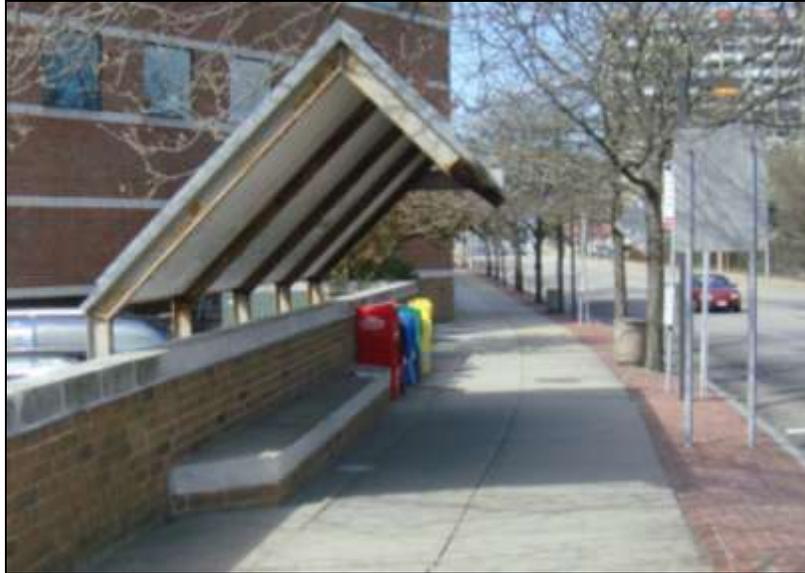
Figure 4: Newton Corner south bus stop

- 4. Lack of Proper Bus Stop:** At the south side stop, we found that the bus shelter was open and unattractive. This current shelter does not protect the bus users from the elements, as displayed in Figure 18. Another challenge at this bus stop was a lack of bicycle racks. There currently are no outside bike racks in the vicinity of the bus stop.

Recommendation: Implement full bus shelter and bike racks. We recommend implementing a full bus shelter at this stop. We were informed by our sponsors that this is the second-most used stop in Newton. Therefore, it is beneficial to shelter the bus patrons from the weather here. We also recommend implementing bike racks at this stop.

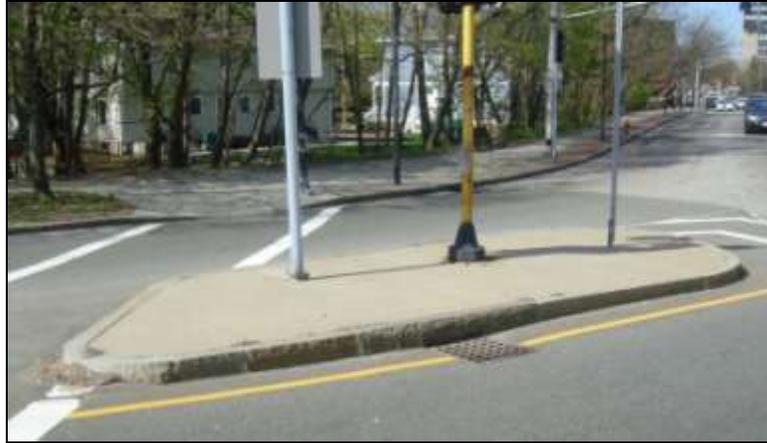
Figure 5: Inaccessible Walking button at Centre Avenue and Park Street

- 5. Inaccessible Walking Button:** A walking light at Park St and Centre Ave also presents a challenge. Here, we found that the walking button is in the center of a raised median thus making it inaccessible to the disabled and elderly, seen in Figure 20. Also, this walking button was not functional. This walking button presents a safety concern as well as violating the ADA regulations on its accessibility. Below are two options for improving the accessibility of the walking light.

Recommendation: Create curb cuts on and off the median. After fixing the walking signal itself, we recommend implementing curb cuts to allow access to the walking button. This will also elevate pedestrians from the level of traffic thus increasing the perception of safety.

Recommendation: Relocate the walking button: After fixing the walking signal itself, we recommend relocating the walking button to the edge of the median. This will make the button accessible from the median cut through.

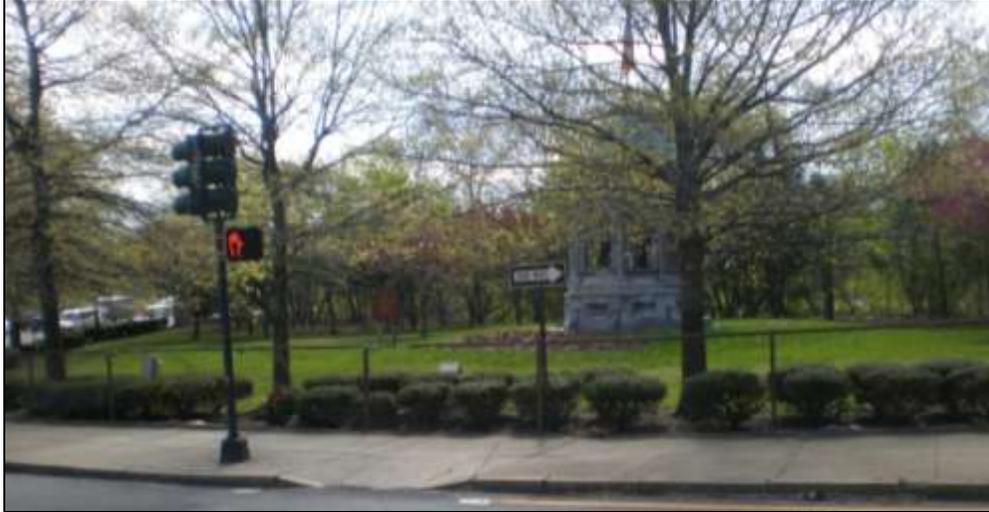
Figure 6: Bell Park on the north side of Newton Circle Rotary

- 6. Closed Green Space:** In Newton Corner, there are not many green open spaces. Therefore, an area for improvement could be the Memorial Bell Park that is currently completely enclosed by a fence, as evident in Figure 21. This area has the potential to be a public area that would attract pedestrians and also offer them a safer path to travel.

Recommendation: Open the park: We recommend opening this park to the public. This could be opened from dawn until dusk in order to prevent problems with misuse, such as vandalism. This will allow residents and employees to enjoy a green space.

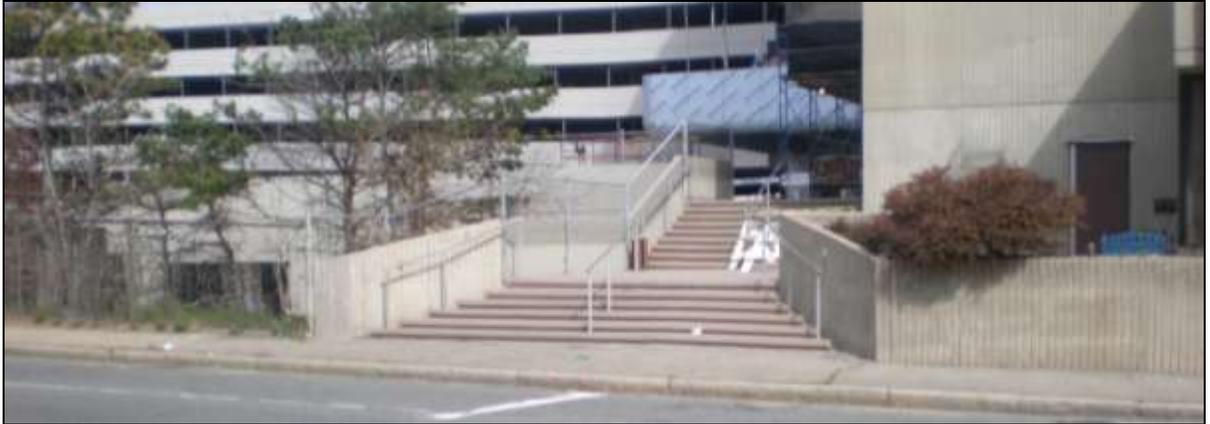
Figure 7: Crowne Plaza path - south side

- 8. Inaccessible Walking Path:** An inaccessible path through the Crowne Plaza hotel was identified as a challenge. This cut through passes over the Massachusetts Turnpike connecting the north and south sides of the village center, shown in Figure 22. However, on the south side, there is a stairway preventing all disabled persons and many elderly from utilizing this path. Without the ability to use this path, pedestrians must walk around the west side of the rotary, which is a long, indirect path for many. During a walkthrough of the area, we noticed an elderly man using a cane traveling around this corner.

Recommendation: Implement a ramp. We recommend the implementation of a pedestrian ramp on the south side of the path to allow access to all persons in accordance with ADA regulations.

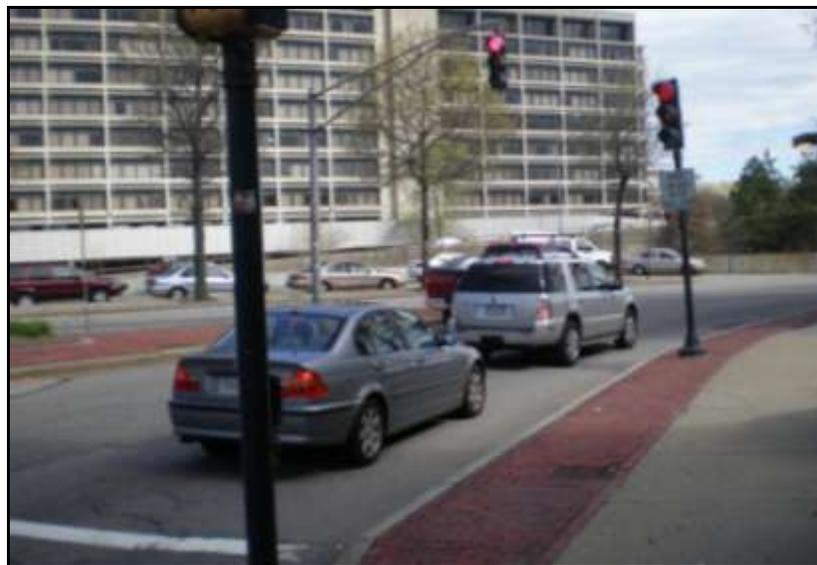
Figure 8: Traffic signals at Centre Street and Centre Avenue

- 9. Improper Placement of Traffic Signals:** The traffic signals for the right turn on Centre Street at the intersection of Centre Avenue are located after the crosswalk, as shown in Figure 23. This causes cars stopped at the light to block the crosswalk and cause a hazard for pedestrians.

Recommendation: Change traffic signals. We recommend moving the light on the median past the crosswalk to the same location as the other traffic light on the

median. Also, we recommend removing the traffic signal on the right hand side of the road altogether.

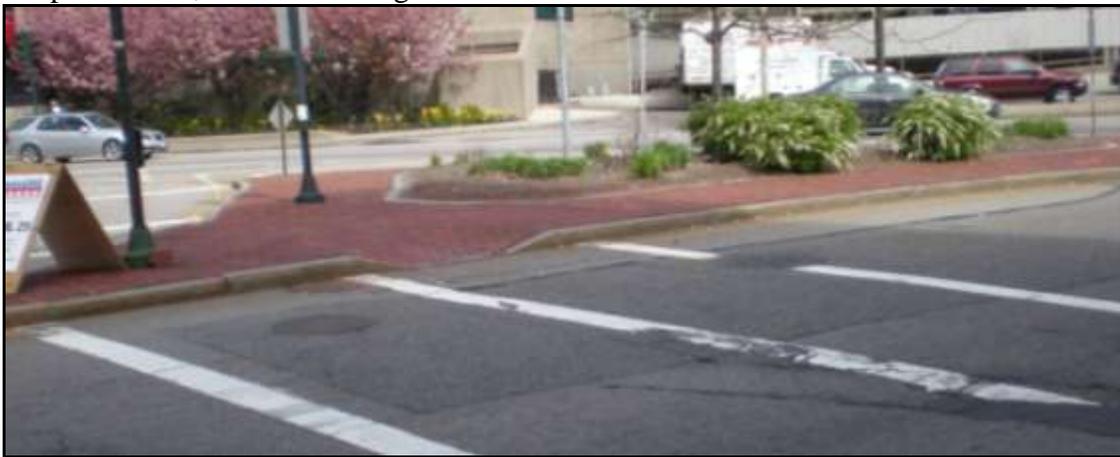
Figure 9: Median at Centre Street and Centre Avenue

- 11. Uneven Median:** The median on Centre Street at the intersection with Centre Avenue is not a level surface and may cause some difficulties for disabled pedestrians, as shown in Figure 24.

Recommendation: Level the surface. We recommend leveling this surface in order to allow safer travel to all pedestrians.
